# TEST REPORT

**Sample Name** : Solar mason jar outdoor lamp

**Model/Item No.** : MO6341

### 1. IP44 test

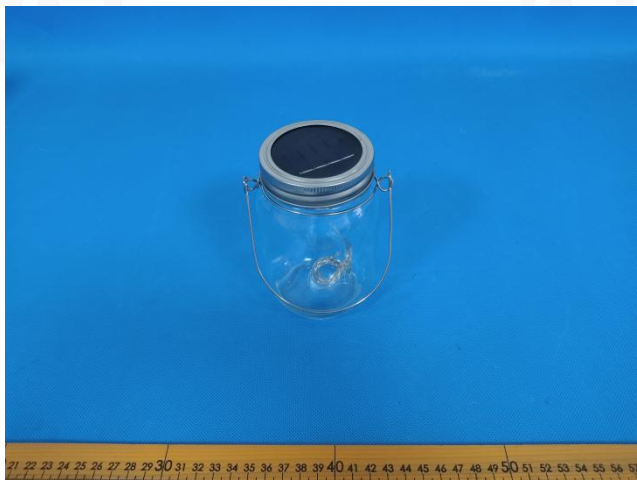
| Product | Before the IP4X test |

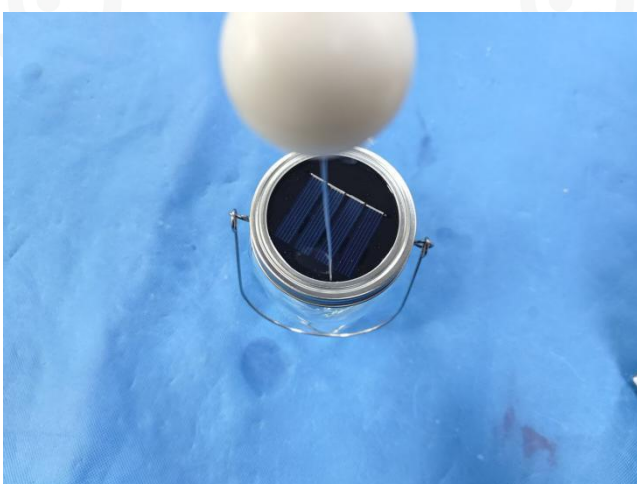
| In IP4X testing | After the IP4X test |

Test straight 1.0mm

Test force 1N

Specimens with a diameter of 1.0mm shall not enter the shell

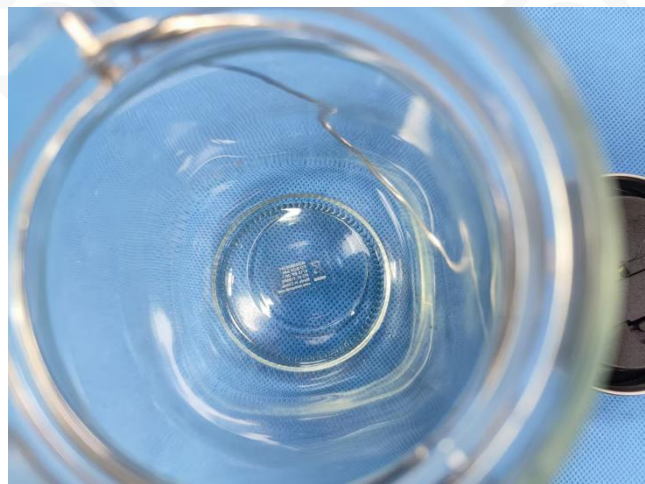
After the IP4X test

| Material No. | Test item | Test result | Test determination |
|---|---|---|---|
| 1 | IP4X | Diameter 1.0mm test device did not enter the shell | PASS |

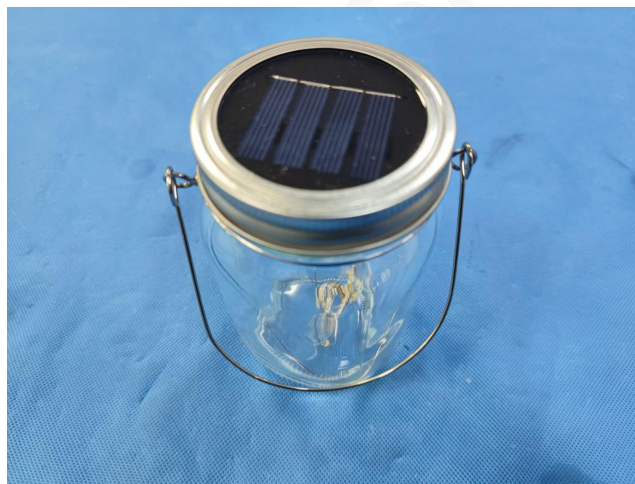
Before the IPX4 test

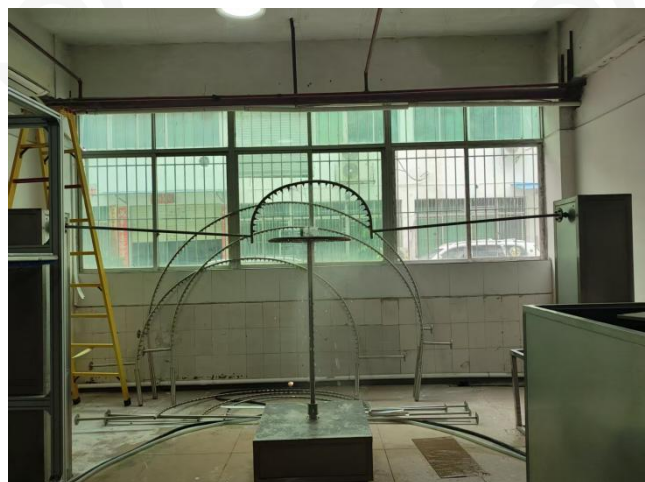
In IPX4 testing

Water flow: 2.6 L/min

Swing tube Angle: vertical direction  $\pm 180^\circ$

Pendulum tube rate: 1 s/60°

Rotary speed: 1 r/min

Test time: 10 min

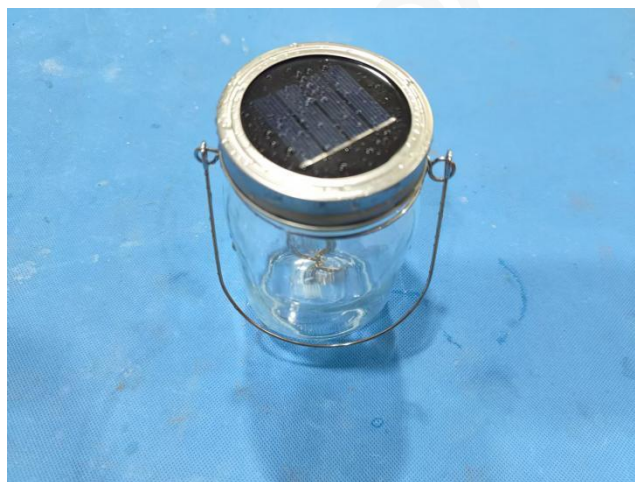
After the IPX4 test

| Material No. | Test item | Test result | Test determination |
|---|---|---|---|
| | IPX4 | After the test, there was no water in the sample | PASS |
